OFFICE OF SURFACE WATER TECHNICAL MEMORANDUM 2017.08

SUBJECT: SonTek 1500 kHz SL 3Gs Data Quality Problems

TECHNICAL SERVICE BULLETIN

Service Number: 17-002

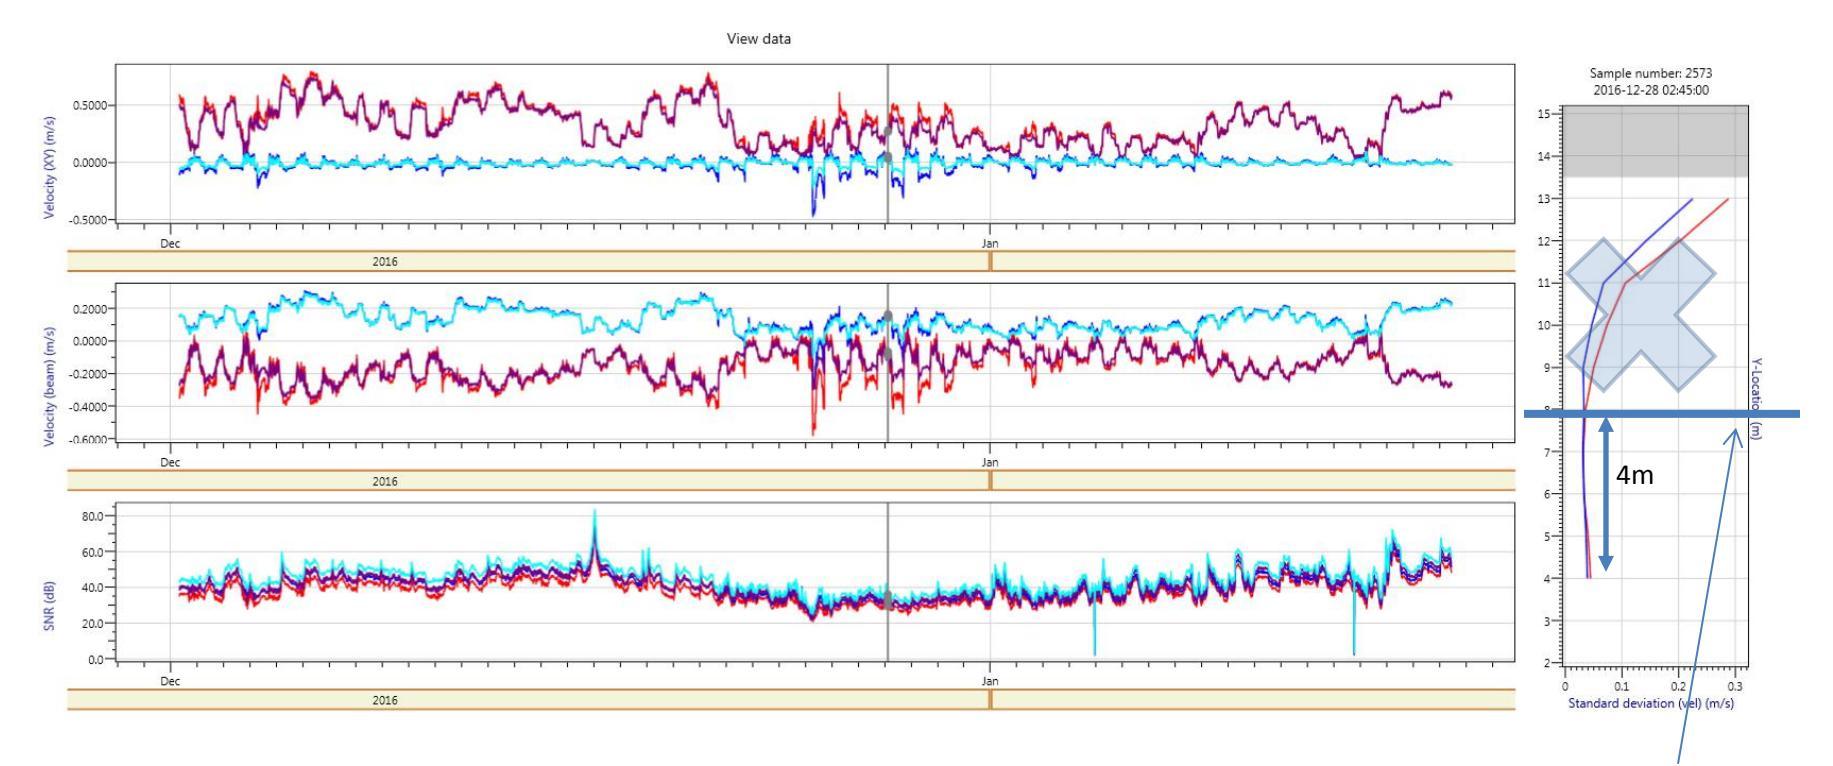
Click through the dataset to view data at different times, and notice the Standard deviation (vel) profile plot. Recall that normally the standard deviation of velocity profile plot should be very straight for both beams throughout the entire profile. The standard deviation from both beams shows an <u>increase</u> beginning at the blue horizontal line in this dataset. Here, data beyond this line should be rejected, and good data before this line can be kept. For this dataset, the amount of data that should be kept ends at <u>**4m**</u> from the instrument itself.

5) Determine to how much you must pull back your Integrated velocity cell for your dataset. In the above example, we observed an increase in standard deviation of velocity at about 8m, which corresponded to good data ending at <u>4m</u> from the instrument. Change the value of Integrated velocity cell end accordingly. Here we change it from 10m to 4m. See before (left) and after (right), below. Notice how the Integrated velocity cell in the diagram is pulled back. Press OK.

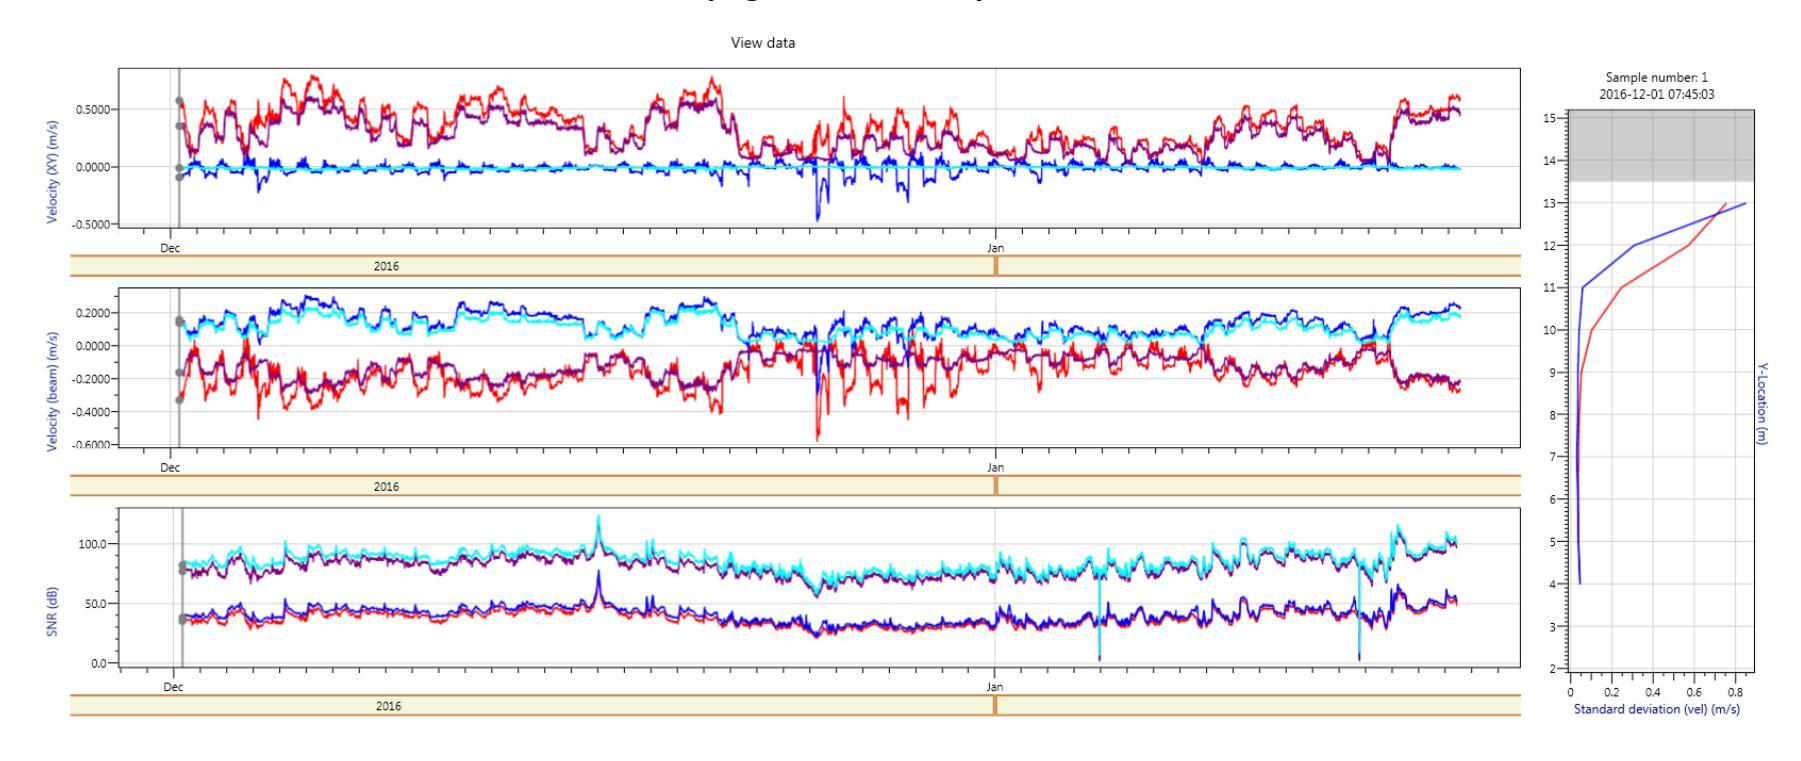
⁷⁾ Notice how this change decreases the noise/variability in the cyan and purple lines:

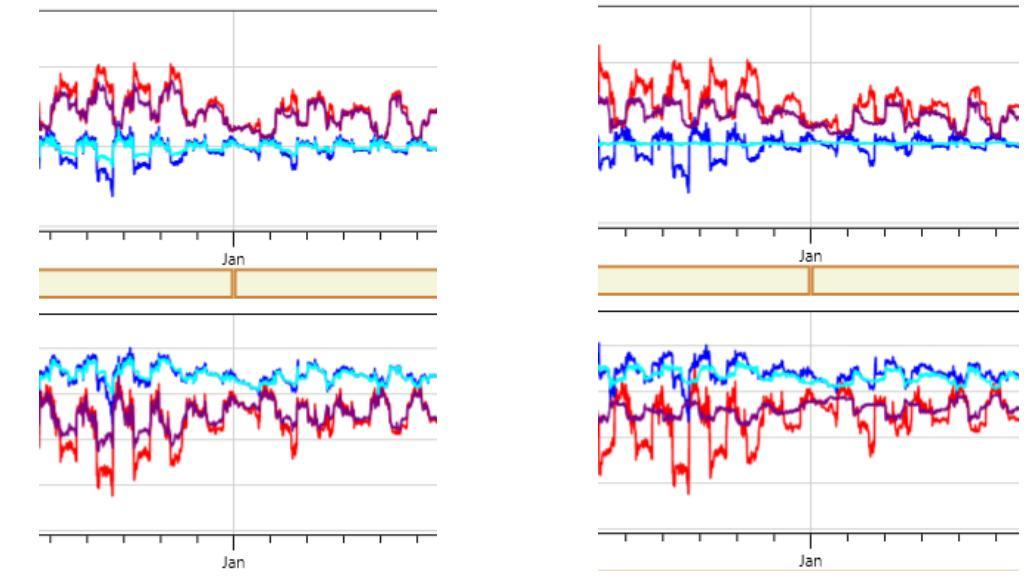
Below are snapshots of a piece of the dataset before (left) and after (right) the recalculation. Notice how the cyan and purple Integrated velocity cell data (both XY and beam) show less noisy variability compared to before. Now the IVC velocity data are reprocessed properly.
